Status Of The Integrated Topping Cycle MHD Generator Testing

STATUS OF THE INTEGRATED TOPPING CYCLE MHD GENERATOR TESTING*

C.C.P. Pian, A.W. Dunton, E.W. Schmitt, and D.J. Morrison
 Textron Defense Systems/Subsidiary of Textron, Inc.
 Everett, Massachusetts 02149

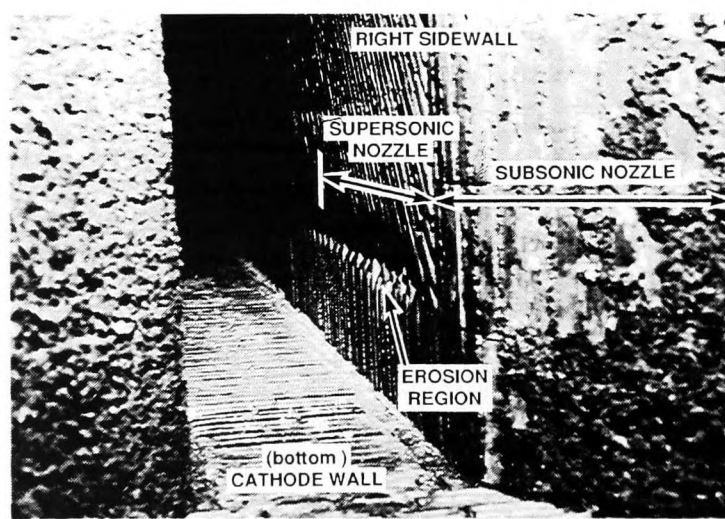
Early in the DVT series, localized damage was found in the lower right sidewall/bottom wall corner region of the inlet nozzle. The bulk of this damage occurred along the path of an axial streamer (about 18 inches long) extending from the nozzle throat to the inlet of the channel. See Figure 8. All of the damaged bars were water-cooled, copper based elements with a 0.375" thick tungsten cap. Throughout the early DVT series, it was also observed that this region of the right nozzle sidewall did not slag well, while the same area on the opposite wall did have better slag coverage. Also, the measured right nozzle

sidewall heat flux was higher than that of the left wall, sometimes by as much as 40 percent.

Two types of surface effects were noticed in the worn regions of the nozzle which suggest two different wear mechanisms. Most of the nozzle wear, particularly in the region of the elongated streamer shaped cavity, had a smooth polished appearance on the surface (Figure 9). This wear appeared to result from erosion by the plasma flow or by the iron oxide wake. Conversely, the wear region located closer to the lower corner of the nozzle had a very rough (orange peel-like) appearance. Metallurgical evaluation of the sidebars removed from this region suggested that the surface wear resulted from oxidation of the tungsten (forming tungstates, WO₃), followed by corrosion of the tungsten oxide. The oxidation of the tungsten caps might have occurred from a reaction with oxygen-rich wakes originating from the second-stage combustor duct. None of the wear was electrical in origin. The most significantly worn elements of the nozzle were replaced during the November 1992 generator channel inspection period.

Figure 8 Photograph of Nozzle Erosion.

Several of the tests during the DVT series were devoted to identifying the cause(s) of nozzle wall erosion. Specifically, this wear problem was addressed by varying the iron oxide injector locations and the number of second-stage oxygen injector nozzles, and their diameters, to improve flow mixing. These modifications reduced flow asymmetry, as indicated by the nozzle sidewall heat flux measurements. In addition, to prevent the iron oxide injectors from plugging due to improper installation, they were modified to insure that they can be set in position in a consistent manner from test to test. After the 93-DVT-28 test, the iron oxide injection ports were relocated further upstream in the second-stage combustor duct, away from the nozzle throat. The nozzle wear rate has slowed significantly (or stopped entirely) as a result of the recent hardware modifications.

Strong secondary flows (corner vortices and swirling flows leaving the combustor and intensified by the converging subsonic nozzle) have also been postulated as an additional possible cause of the observed nozzle wall erosion.⁷ Efforts have been initiated to fabricate nozzle elements with a more gradual variation in the nozzle cross-sectional area. However, the fact that recent inspections of the nozzle have indicated that wear has slowed substantially (or even stopped) suggests that corner vortices may not be a major contributor to nozzle wear. This will be verified by more careful wear measurements during the next channel inspection and refurbishment period.

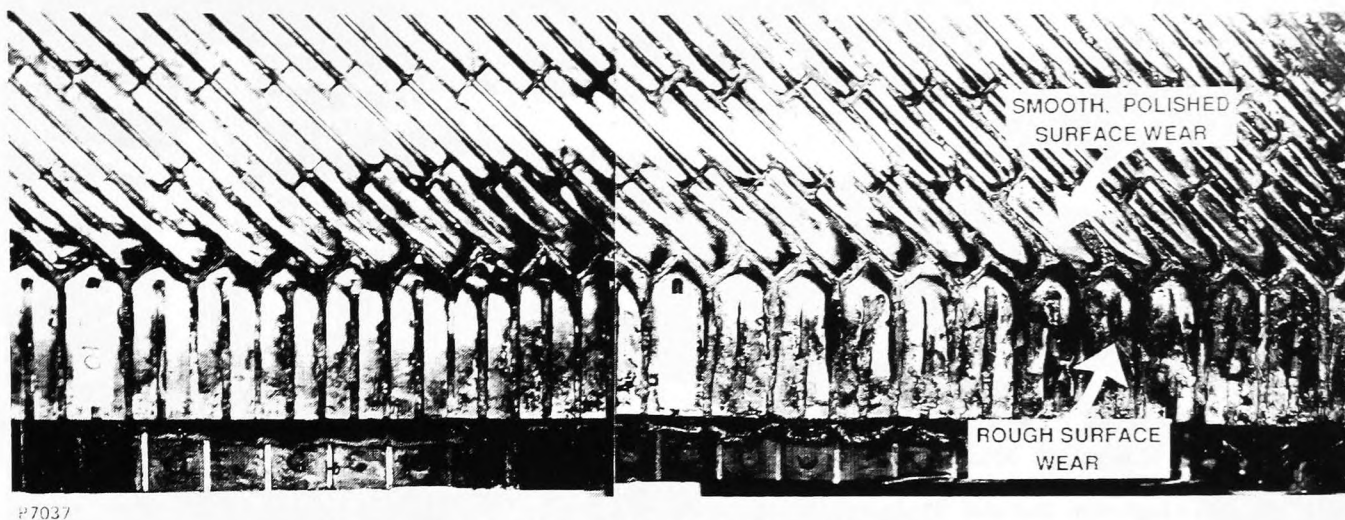
Figure 9 Details of the Right Sidewall Nozzle Wear.

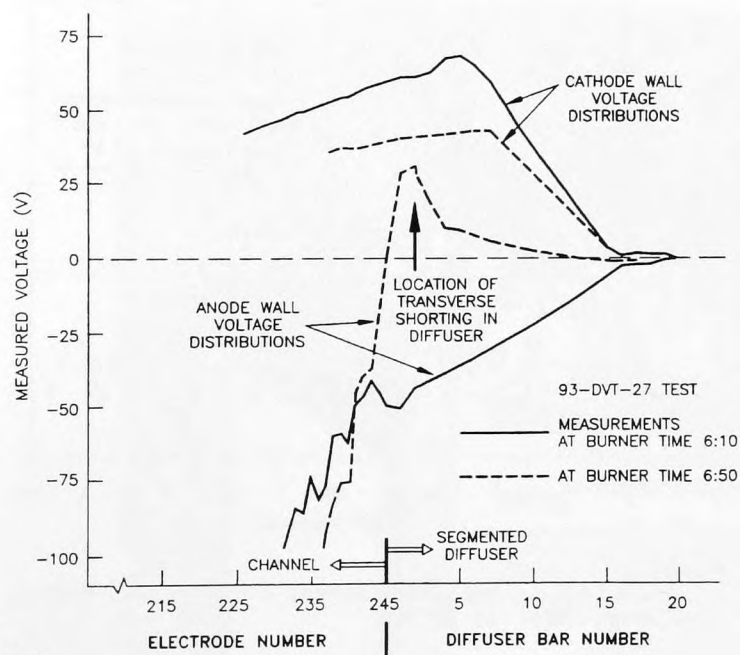
The power test 93-DVT-36 (March 1, 1993) was terminated as a result of a gas leak in the supersonic diffuser, just downstream of the channel/diffuser interface. From analysis of operational data and a post-test inspection of the diffuser, it was determined that the gas leak was due to failure of the G-11 back wall caused by electrical shorts and circulating currents in the diffuser.

A review of electrical data indicated that the shorts in the diffuser started during the first power generation test after the November 1992 channel/diffuser rebuild. Figure 10 shows the variation in the measured anode and cathode wall

voltage distributions at the aft end of the channel. At the start of the test, the Faraday voltages in the segmented diffuser section were in excess of 80-100 volts. Immediately after the start of the test, the measured Faraday voltages dropped steadily for 40 minutes, at which time the Faraday voltages were all less than 30 volts. This decrease in the Faraday voltages resulted from an electrical short located at the second diffuser frame downstream from the channel/diffuser interface. These reduced Faraday voltages persisted throughout all subsequent tests up to and including test 93-DVT-36. The results of Figure 10 suggest that the existing diffuser design and construction method did not provide the insulation necessary to sustain the Faraday voltage generated by the fringe magnetic field. The existing transverse segmentation (3 insulator gaps) is too coarse.

Figure 10 The Measured Voltage Distributions in the Diffuser During 93-DVT-27 Test.

The external electrical loading was reconfigured to better distribute the Faraday voltage in the diffuser. This was done by adding Faraday load resistors between the diffuser sidebars, thus allowing some currents to circulate in exchange for high gap voltages. In addition, Faraday grading resistors were added to the last few channel electrodes to minimize the voltage mismatch present at the channel/diffuser interface. In order to repair the diffuser and resume the duration testing as quickly as possible, a noncharring G-7 fiberglass liner (similar to the liner used in the channel) was placed under the first four bar frames of the diffuser to prevent possible electrical shorting of the back walls.

This solution for controlling the diffuser voltage is working well. There have been no indications of electrical breakdowns or shortings during recent power tests.

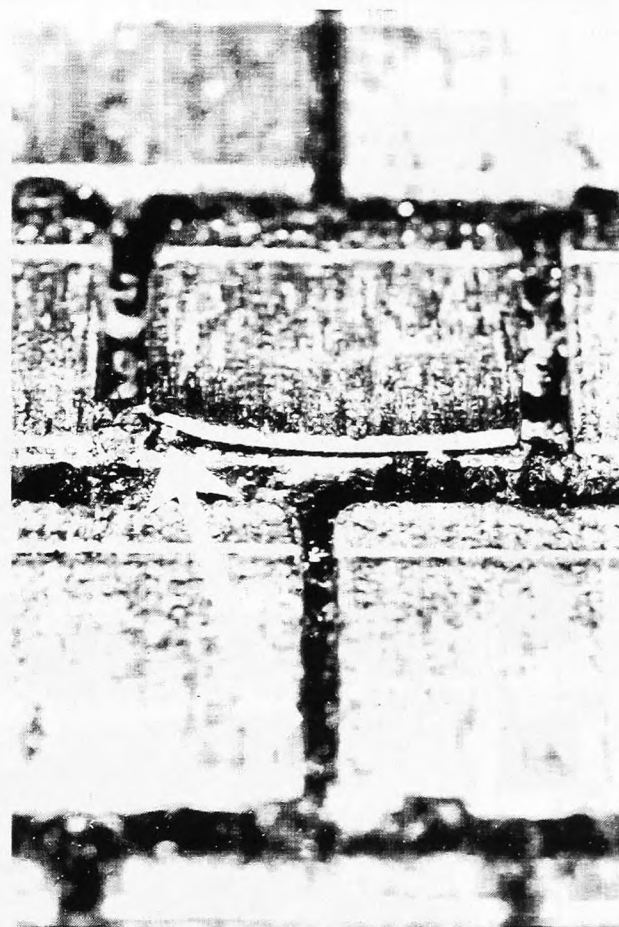
During the generator inspection at the completion of the initial DVT series in November 1992, it was discovered that the platinum top caps had separated from approximately 5 percent of the platinum-clad tungsten anode caplets. The lifting of the platinum top caps appeared to have been initiated by the failure of the braze joint and the resulting separation of the cap at the trailing edge of the caplets. An enlarged view of a partially lifted cap is shown in Figure 11. This separation of the top cap eventually leads to melting of the platinum from overheating. About 126 out of the total 2200 Pt/W caplets on the anode wall were found to be missing all or part of the platinum top cap as a result of this type of braze deficiency. None of the anodes with missing platinum top caps were replaced at the time of the channel inspection, although some of the partially lifted caps were removed. The 1A₄ generator channel was then reboxed to allow the continuation of DVT.

Records of the anode fabrication and brazing histories were reviewed in an attempt to correlate lifted top caps to specific fabrication techniques and/or oven braze cycles. Nearly 70 percent of the lifted anode caps were produced in fewer than 10 percent of the Pt/W caplet subassembly braze cycles. The remainder of the platinum cap losses appear to be random, and most likely represent the "infant mortality" failures anticipated during the DVT series.

The loss of platinum anode top caps is not life-threatening to the ITC generator tests. At the time of the anode wall inspection, in November 1992,

there was no evidence of any wear on the exposed tungsten surfaces where the platinum cap material was missing. The purpose of the back-up tungsten capping is precisely to protect the anodes against the possible loss of the platinum top caps. The results of materials duration tests carried out previously in the Textron Mk-VII MHD facility have indicated that the prototypic anode design can operate in excess of 1400 hours in the absence of a Pt top cap.⁸

Figure 11 A Close-Up View of the Lifted Trailing Edge of a Platinum Top Cap.

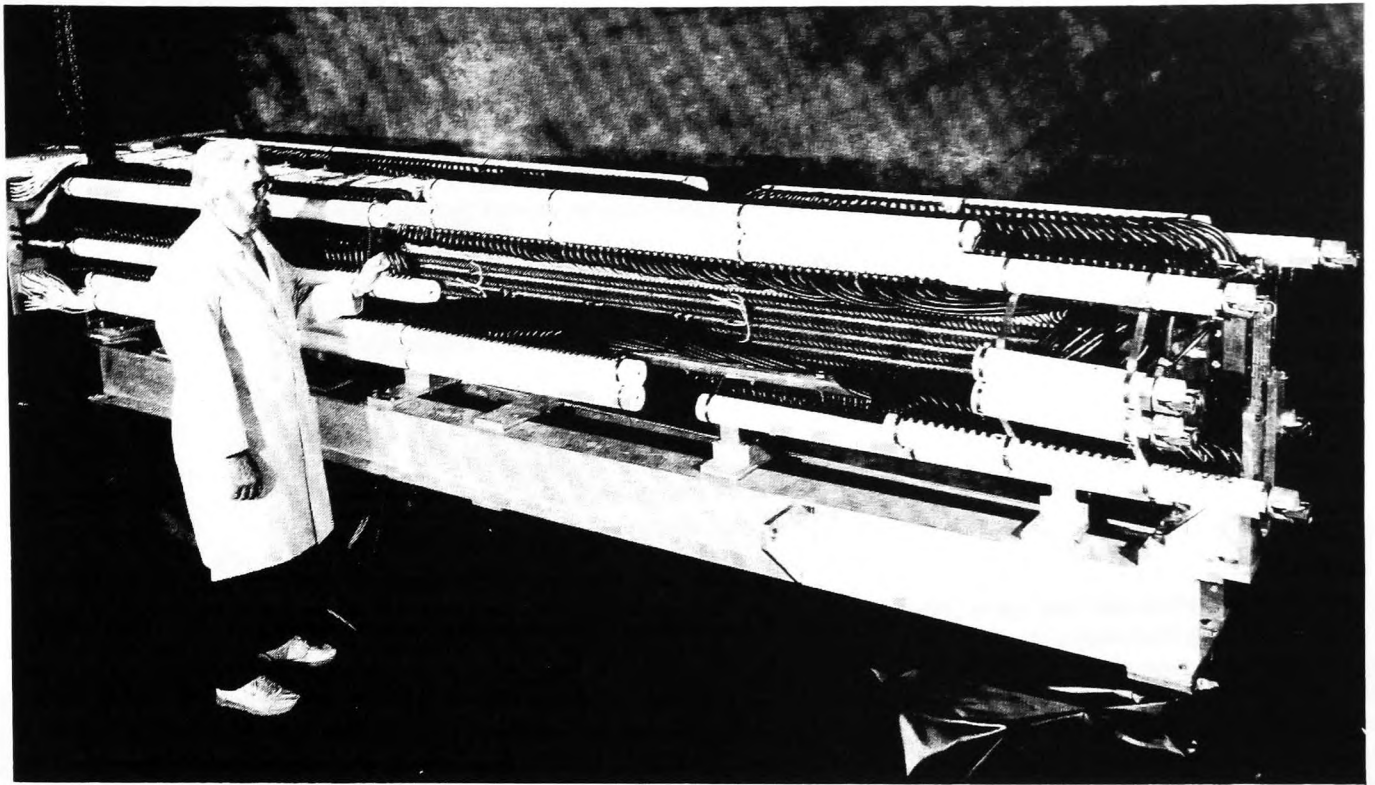
Inspections of the generator channel gas-side surfaces have shown no evidence of unusual wear or signs of water leaks. In addition, there have been no indications of any reduction in the channel electrical integrity.

Figure 17 1A₄ Prototypic MHD Generator Channel

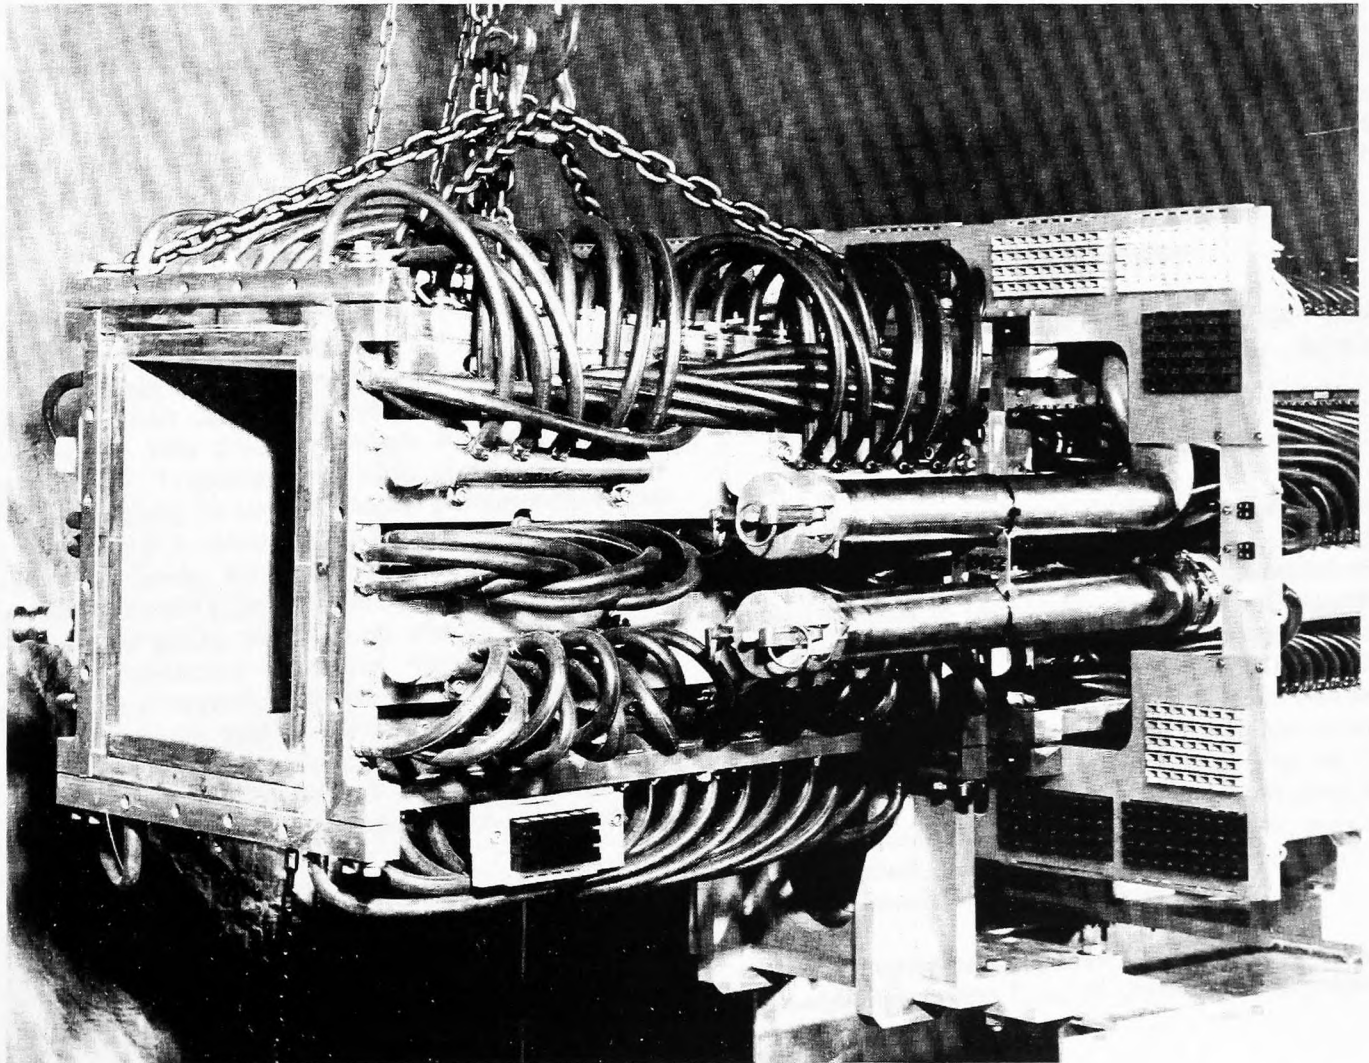
Inspection of the nozzle area is performed at every opportunity. No discernible increase in wear has been observed since the oxygen port reconfiguration was completed. In addition, the performance of the forward segmented diffuser has continued to be good throughout duration testing. The placement of resistors between the sidebars is

effective in redistributing the Faraday voltage between the transverse diffuser segments. Also, the Faraday voltage in the diffuser region remains steady, indicating an absence of internal shortings.

Figure 18 1A₄ Segmented Supersonic Diffuser
